Royal Commission on the Pike River Coal Mine Tragedy

Volume 2

Date of Publication: October 2012

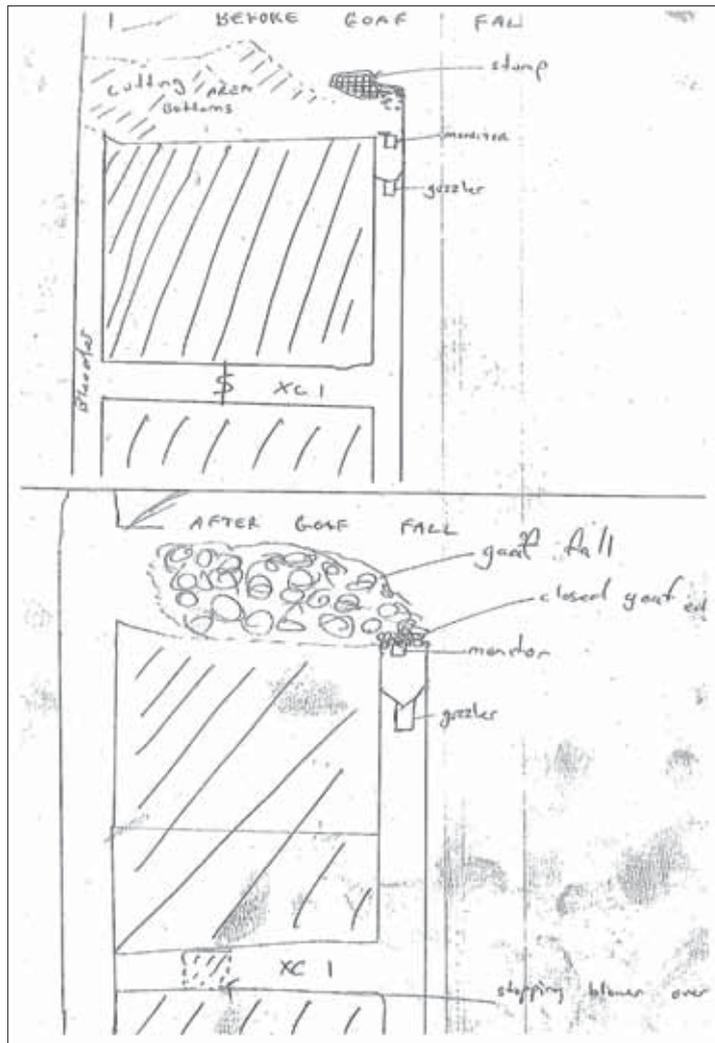
Figure 8.15: Effects of roof fall on 30 October 2010¹⁷¹

119. Mr Wylie completed an incident report.¹⁷⁰ He attached a hand-drawn diagram showing the effects of the roof fall, including the blocked heading at the entry to the goaf and the damaged stopping in cross-cut one, with the words 'stopping blown over'.
