Royal Commission on the Pike River Coal Mine Tragedy

Volume 2

Date of Publication: October 2012

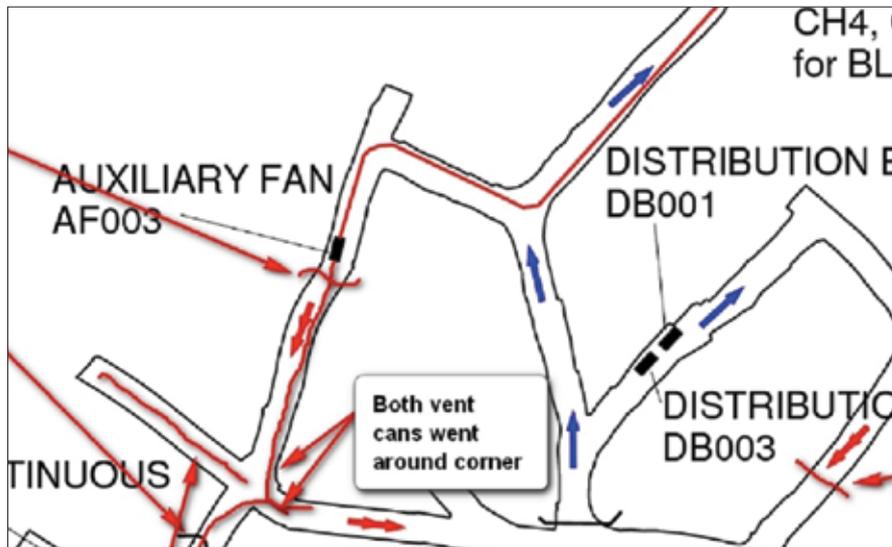
Figure 8.18: Location of the auxiliary fan²⁰¹

136. DOL concluded that, given the gas make in the mine and the number of faces being worked, it should have been apparent that the ventilation system was stretched to its limit. Pike's approach allowed no factor of safety to deal with predictable hazards.¹⁹⁹
137. Mr Reece also noted other deficiencies with the ventilation system, for example, the placement of an auxiliary fan (AF003) immediately next to a stopping,²⁰⁰ which meant the fan did not have the necessary 30% of fresh air passing over it to ensure it did not overheat. The fan can be seen towards the left-hand side of the following diagram.

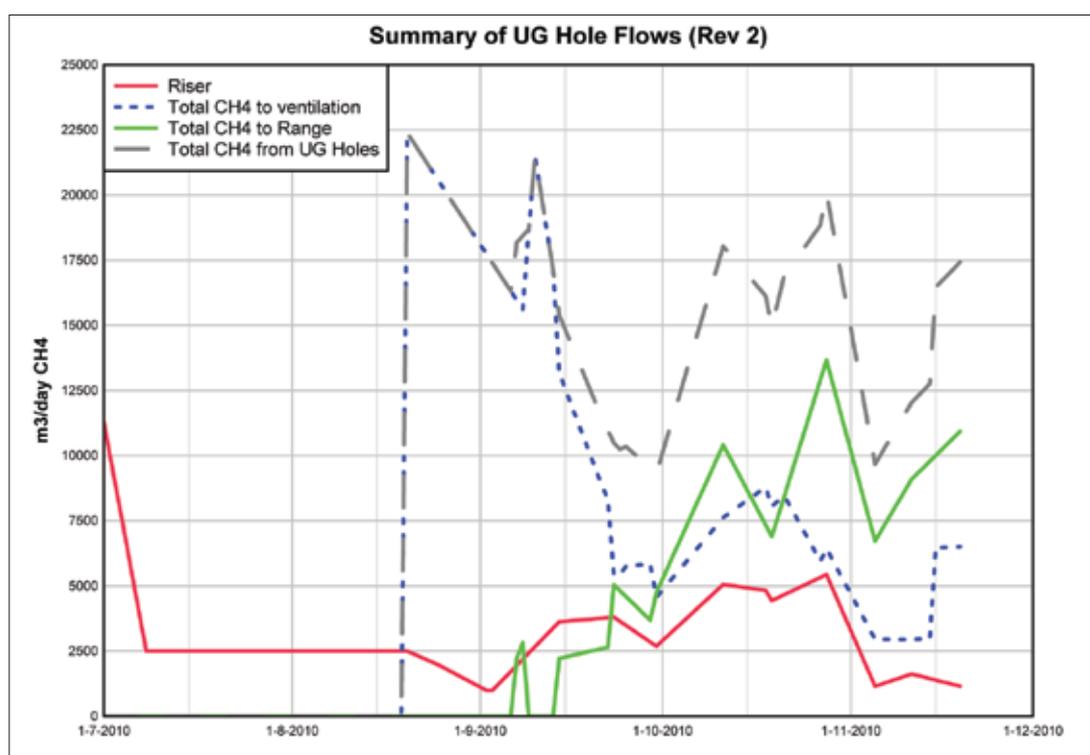
Figure 9.9: Graph summarising total daily drainage system gas flow measurements¹⁵⁰

126. The following graph prepared by the joint investigation expert panel¹⁴⁹ summarises the total daily methane volumes (m^3/day) for the drainage system gas from July 2010 until the explosion. The red line depicts the volume of methane measured at the bottom of the gas riser, which decreases from the beginning of July when the practice of free venting began with GBH012 disconnected from the range. The blue line shows the volume of methane free vented to the mine's atmosphere for dilution by ventilation; and the grey line shows the total methane flow from all boreholes. These measurements began on 20 August 2010, the start of gas flow measurement from individual boreholes. The green line shows the total methane volume flowing into the range from September 2010 when weekly gas drainage measurements commenced.

127. The noteworthy features are the high volume of methane free vented when compared to the volume of gas entering the range, and the difference between the volumes entering the range and reaching the bottom of the riser. For example, on the day of the explosion the measured gas flow into the range was 126.4l/s but only 13.3 l/s was measured at the gas riser. Such discrepancies dated back to the beginning of October. Various explanations for the difference have been suggested including leakage, methane back-feeding into other areas, a blockage in the range or incorrect measurements at the gas riser.¹⁵¹
128. As late as 27 October 2010, there was no accurate recording of methane emissions and no comprehensive system in place to capture, record and store all data permanently.¹⁵²
129. The expert panel criticised Pike's gas management approach:

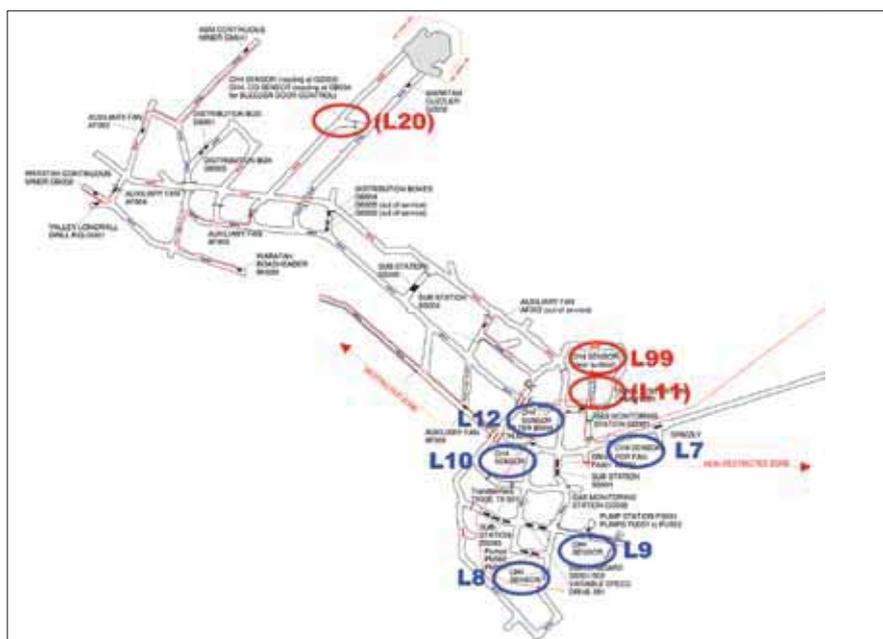
Figure 10.1: Location of fixed methane sensors²²

11. As at 19 November 2010 there were eight fixed methane sensors connected to the surface control room,²¹ shown in Figure 10.1.

- The five sensors circled in blue were all located within the intake roadways, in areas expected to be ventilated by fresh air. These sensors were located at or near electrical equipment in an area Pike designated as the 'non-restricted zone'. Regulations require the non-restricted zone to contain no more than 0.25% flammable gas. The sensors in this area at Pike River were set to trip power at 0.25% methane.

- The sensor at L11 stopped working on 4 September 2010,²⁴ and the sensor at L20 stopped working on 13 October 2010,²⁵ leaving Pike with no gas sensors reporting to the surface from further into the return than the ventilation shaft. This did not give the mine adequate information about the location, source and quantities of flammable gas within the mine. Surface controller Barry McIntosh said the controllers had raised the issue of the location of gas sensors, and in his view the gas sensors 'weren't up far enough' in the mine.²⁶

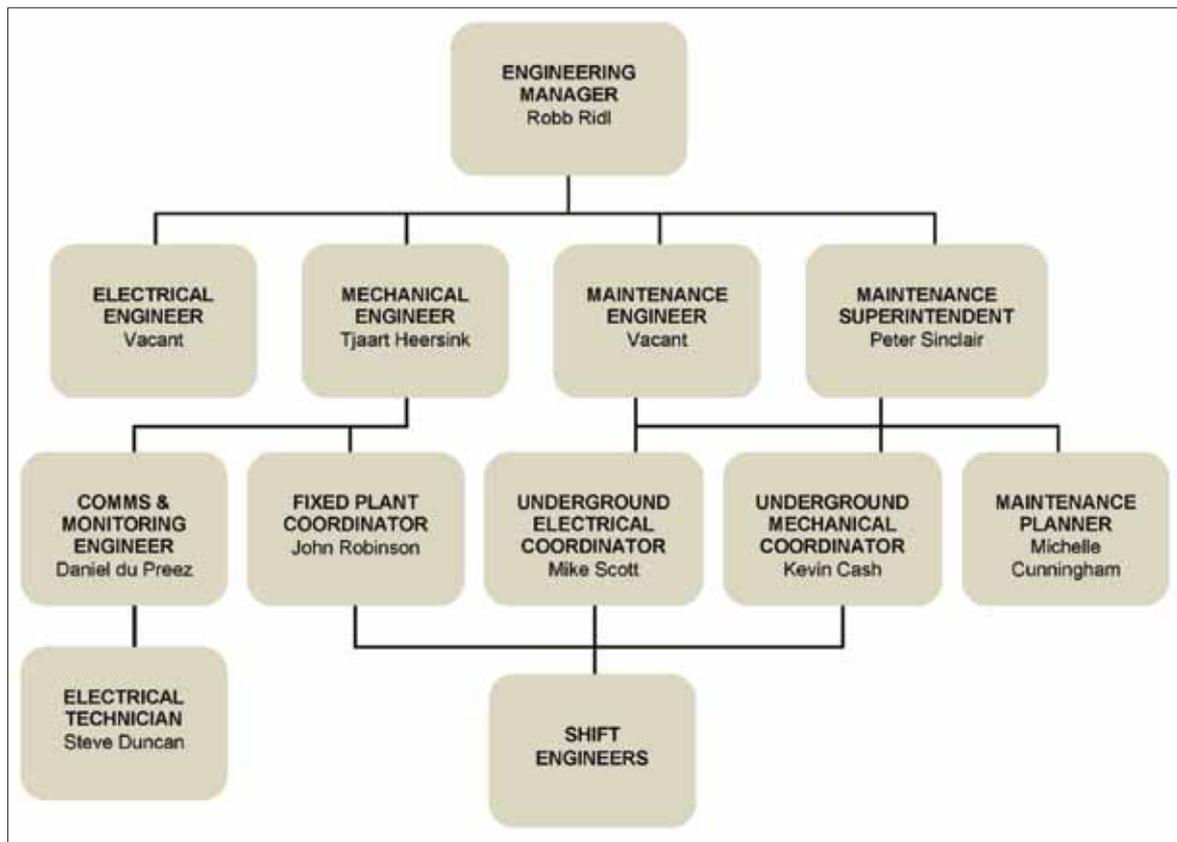
Figure 11.5: New structure for Pike engineering department⁴³

43. A new structure with increased staffing was proposed and was approved by Douglas White and Peter Whittall (see Figure 11.5).⁴¹ It included the position of electrical engineer.
44. This was not as senior as the position suggested by Mr Reczek but did include responsibility for many aspects of the electrical system, including risk management, ensuring maintenance in accordance with statutory requirements, electrical inspections and continuous improvement.⁴²

45. By 19 November 2010 an electrical engineer, a contractor who had been an electrical co-ordinator, had been appointed but he had not started in the new position.⁴⁴

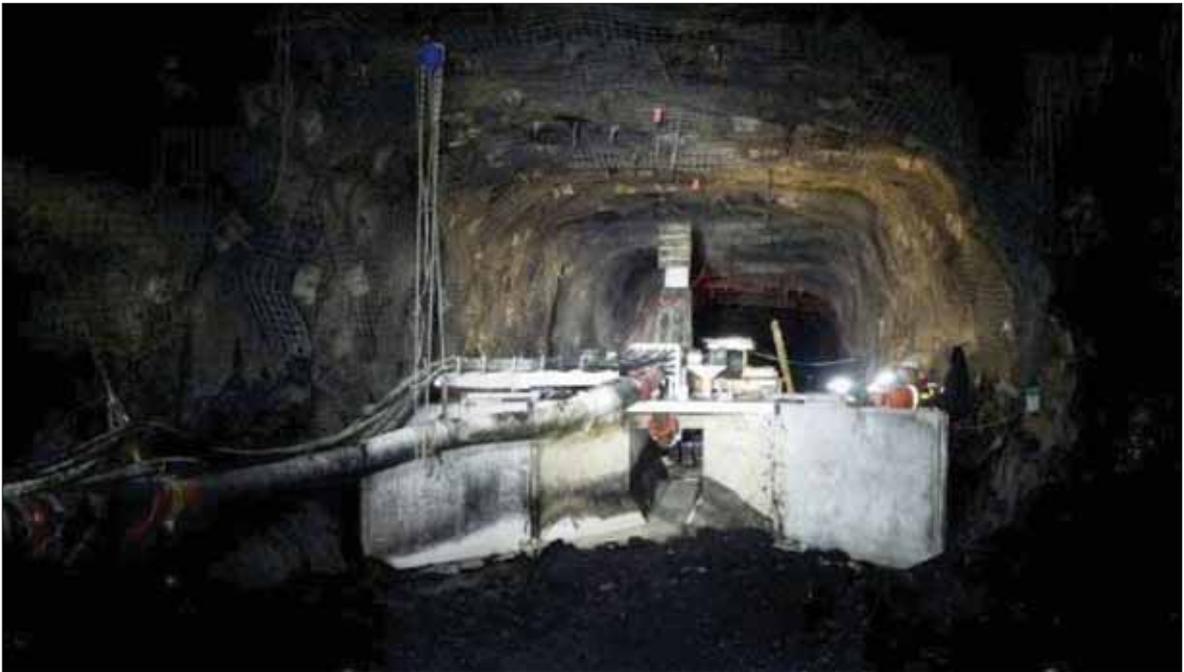
Figure 12.4: Guzzler ready to gather and direct water/coal mixture⁶

5. At Pike River a machine called a guzzler was located 18m behind the hydro monitor, and directed the mixture of coal and water into the roadway flume system. The guzzler also crushed any large lumps of coal.⁵ It is shown in the photograph with its 'wings' open ready to gather and direct the coal/water mixture.

54. Mr Nishioka's work record during the monitor's first week of operation noted that:
- the guzzler was too large and complicated;
 - it was hard for the operator to see the direction of the monitor nozzle, because vision was blocked by the housing;

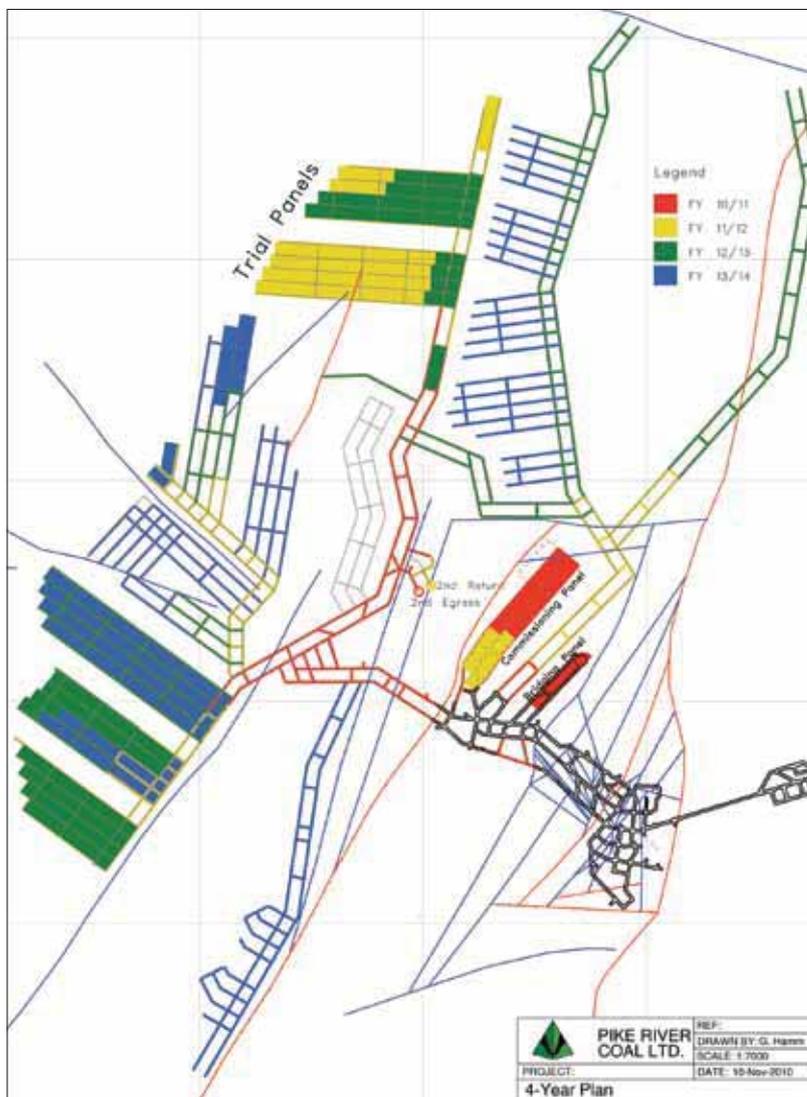
Figure 12.7: Pike's Four-year Plan for 2010–2014²⁵

19. In May 2010 DOC approved another variation for Pike to reduce the number of bridging panels and move the first panel closer to pit bottom.²⁴ This became known as panel 1 and is shown in Figure 12.7, as 'Bridging Panel'.

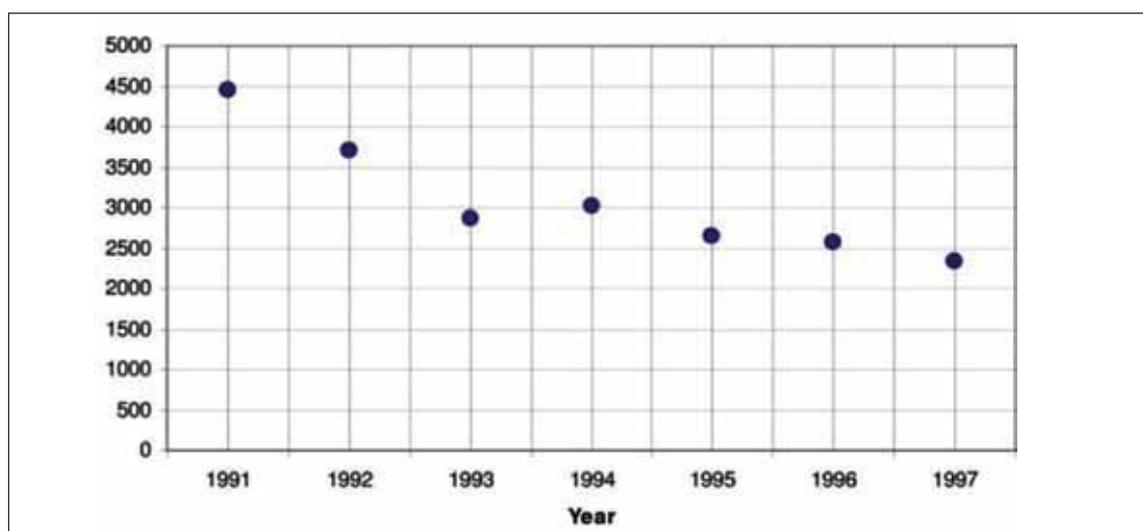
21. The inspection frequency reduced. In 1993–94 all underground mines were to be inspected every two months. In 1995 that reduced to every three months because an 'increased emphasis on education and training' made the greater frequency unrealistic.²⁶ A 1996 mining inspectorate report 'indicates that a continued shortage in staff numbers and an increase in educational activities resulted in a reduction in field inspection work'.²⁷ The declining number of minerals and coal inspections over the 1991–97 period is shown in Figure 22.1.

Figure 22.1: Number of minerals and coal inspections 1991–97²⁸

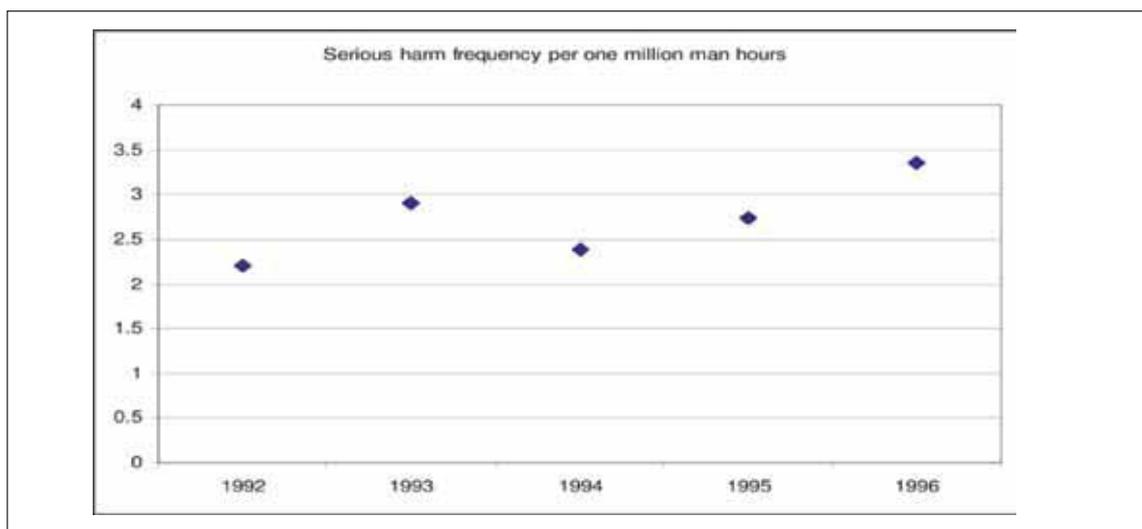
22. At the same time, mining serious harm frequency rates increased, as shown in Figure 22.2. The MIG's 1995 annual report noted that mine operators considered 'reduced inspection frequency and lack of mining regulations' were contributing factors.²⁹

Figure 22.2: Serious harm frequency rates³⁰

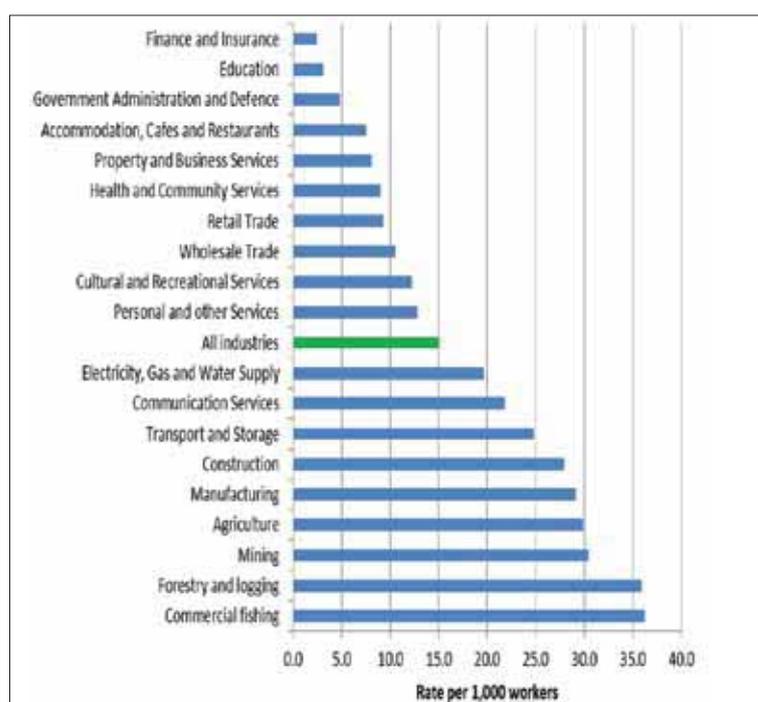
Figure 24.4: Highest risk sectors – injury rates⁶⁵

44. Although mining had the third highest injury rate, in contrast to the construction, agriculture, forestry, manufacturing and fishing industries, it was not seen as a priority area.⁶⁶ This seems to be because of a focus on industries with 100,000 or more full-time equivalent workers.⁶⁷ This approach was too blunt.
